UNDERWATER BRIDGE INSPECTION REPORT

STRUCTURE NO. 30507

RUM RIVER

MINNESOTA DEPARTMENT OF TRANSPORTATION
UNDERWATER BRIDGE INSPECTION

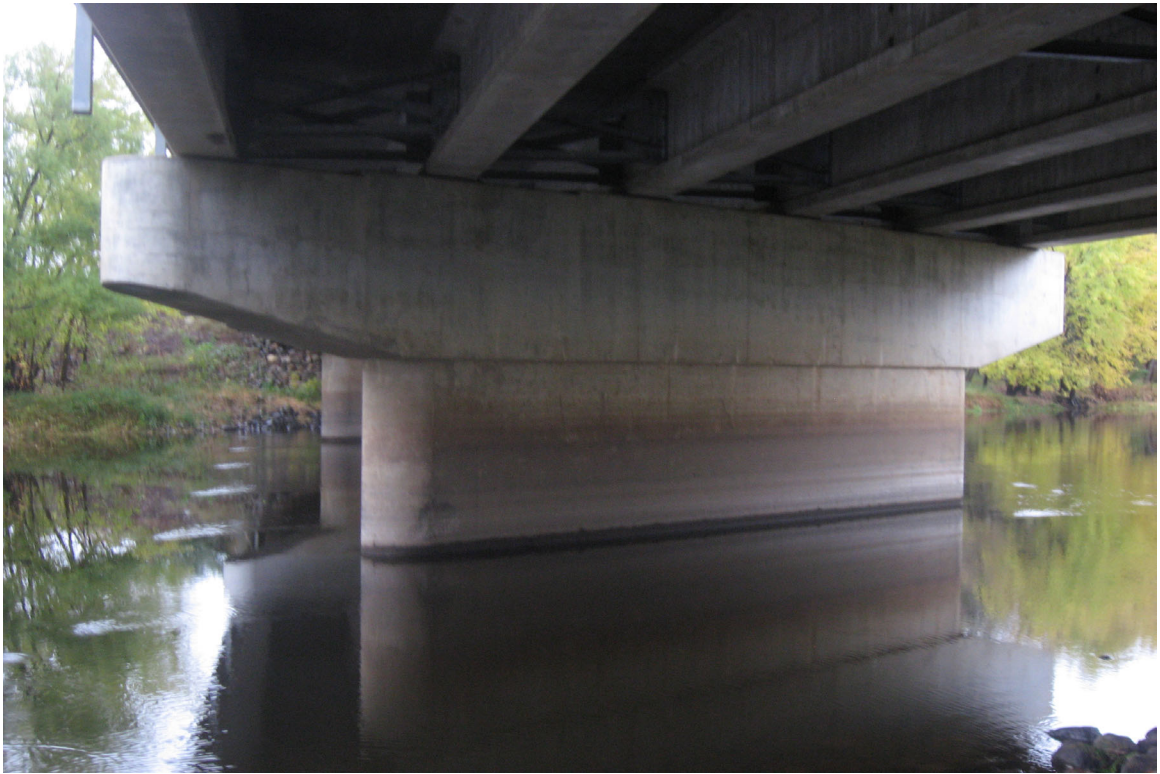
- (B) Two 1 foot high areas of moderate to heavy scaling were observed on the east face of Pier 1 at the waterline. The first one was 2 feet long with 1 inch penetration located 6 feet south of the upstream nose. The second area was 1 foot long with $\frac{1}{2}$ inch penetration located 14 feet south of the upstream nose.

- (E) Light to moderate accumulations of timber debris were observed at Piers 1 and 2, with debris around the upstream nose at Pier 1 and along the west side at Pier 2.

Photograph 1. View of Pier 1, Looking East.

- (A) Monitor the timber drift that has accumulated around the piers, and if found to be progressing to the point of influencing or becoming excessive, then removal operations may become necessary.
- (B) Reinspect the submerged substructure units at the normal maximum recommended (NBIS) interval of five (5) years. Continue to monitor the footing exposure at Pier 2 during future inspections.

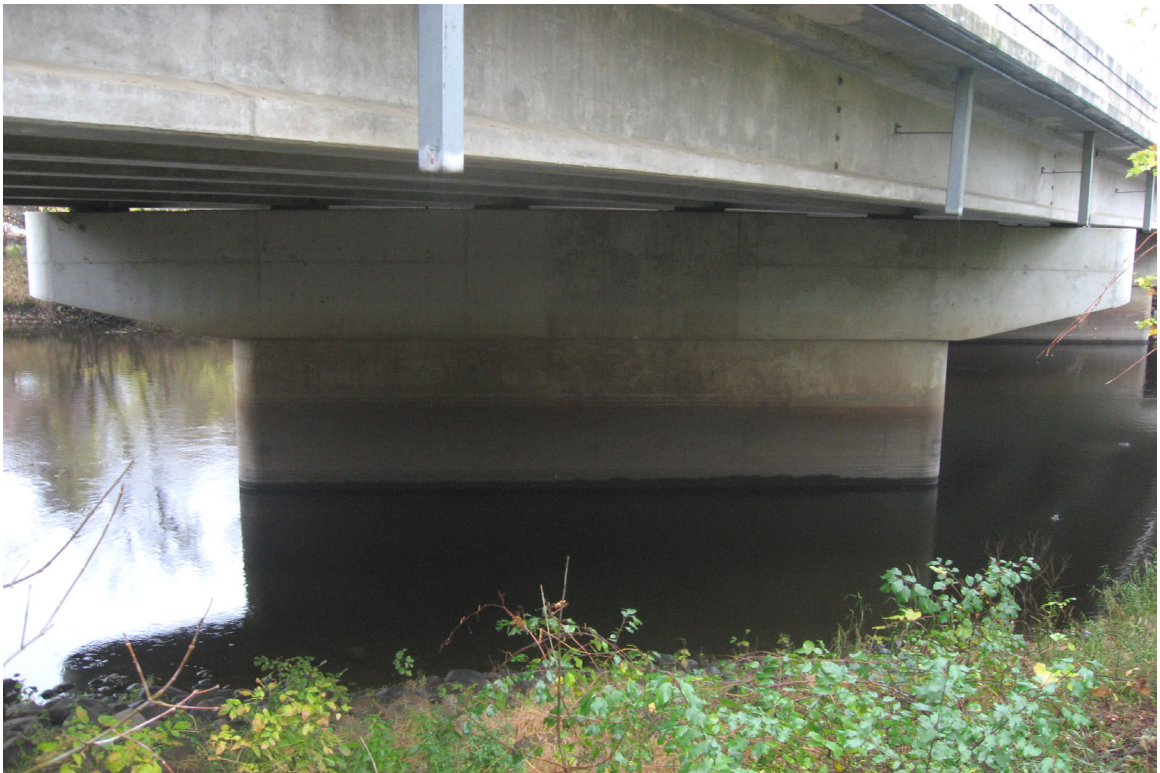
- (C) A 3 feet deep scour depression was present along the entire west face of Pier 2, extending up to 5 feet off the pier face.
- (D) A portion of the top of footing along the west side of Pier 2 was exposed, with no vertical exposure, extending from midpoint to the downstream quarter point on the pier shaft. The surface of the exposed footing exhibited moderate scaling with penetrations of up to $\frac{1}{4}$ inch in depth.

Photograph 2. View of Pier 2, Looking West.

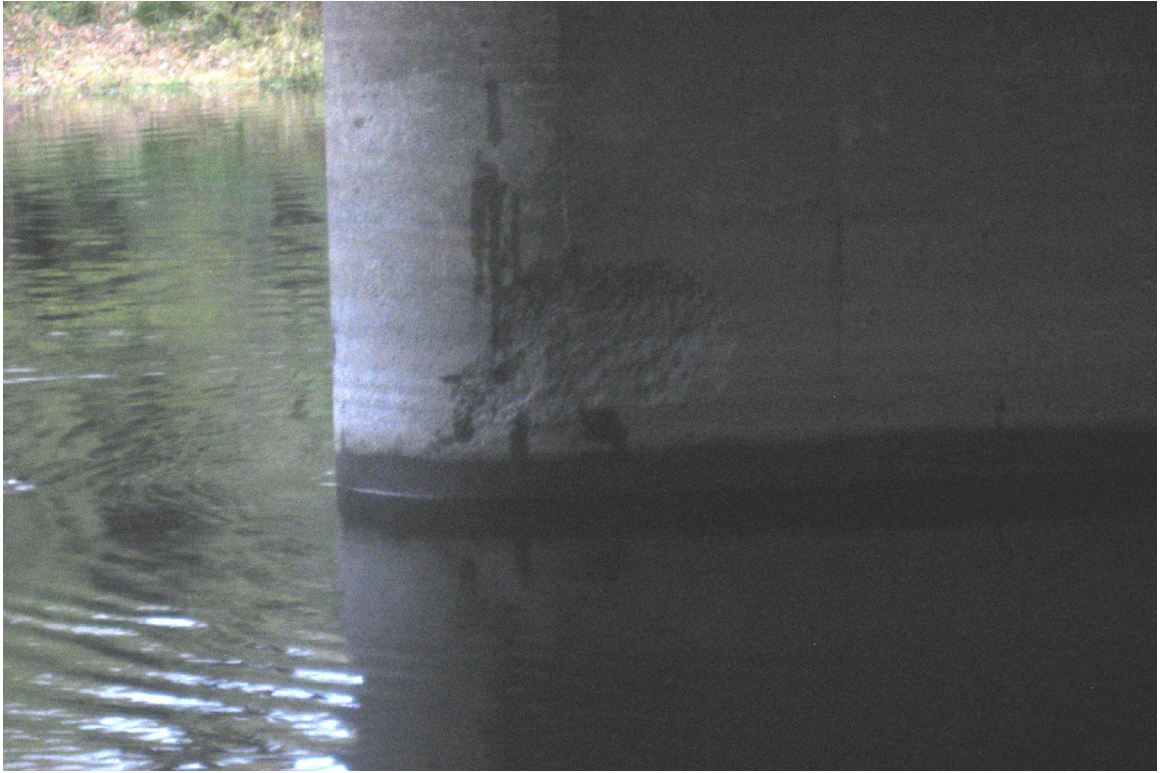
- (A) A 2-foot-long by 6-inch-high area of moderate scaling with a penetration of $\frac{1}{2}$ inch was observed at the northwest corner of Pier 1 extending from 1 foot to 1.5 feet above the waterline.

Photograph 3. View of Moderate Scaling at the Northwest corner of Pier, Looking East.

- A 2-foot-long area of moderate scaling was located at the western upstream side of Pier 1 and extended from 1 to 1.5 feet above the waterline with up to 1/2 inches of penetration.

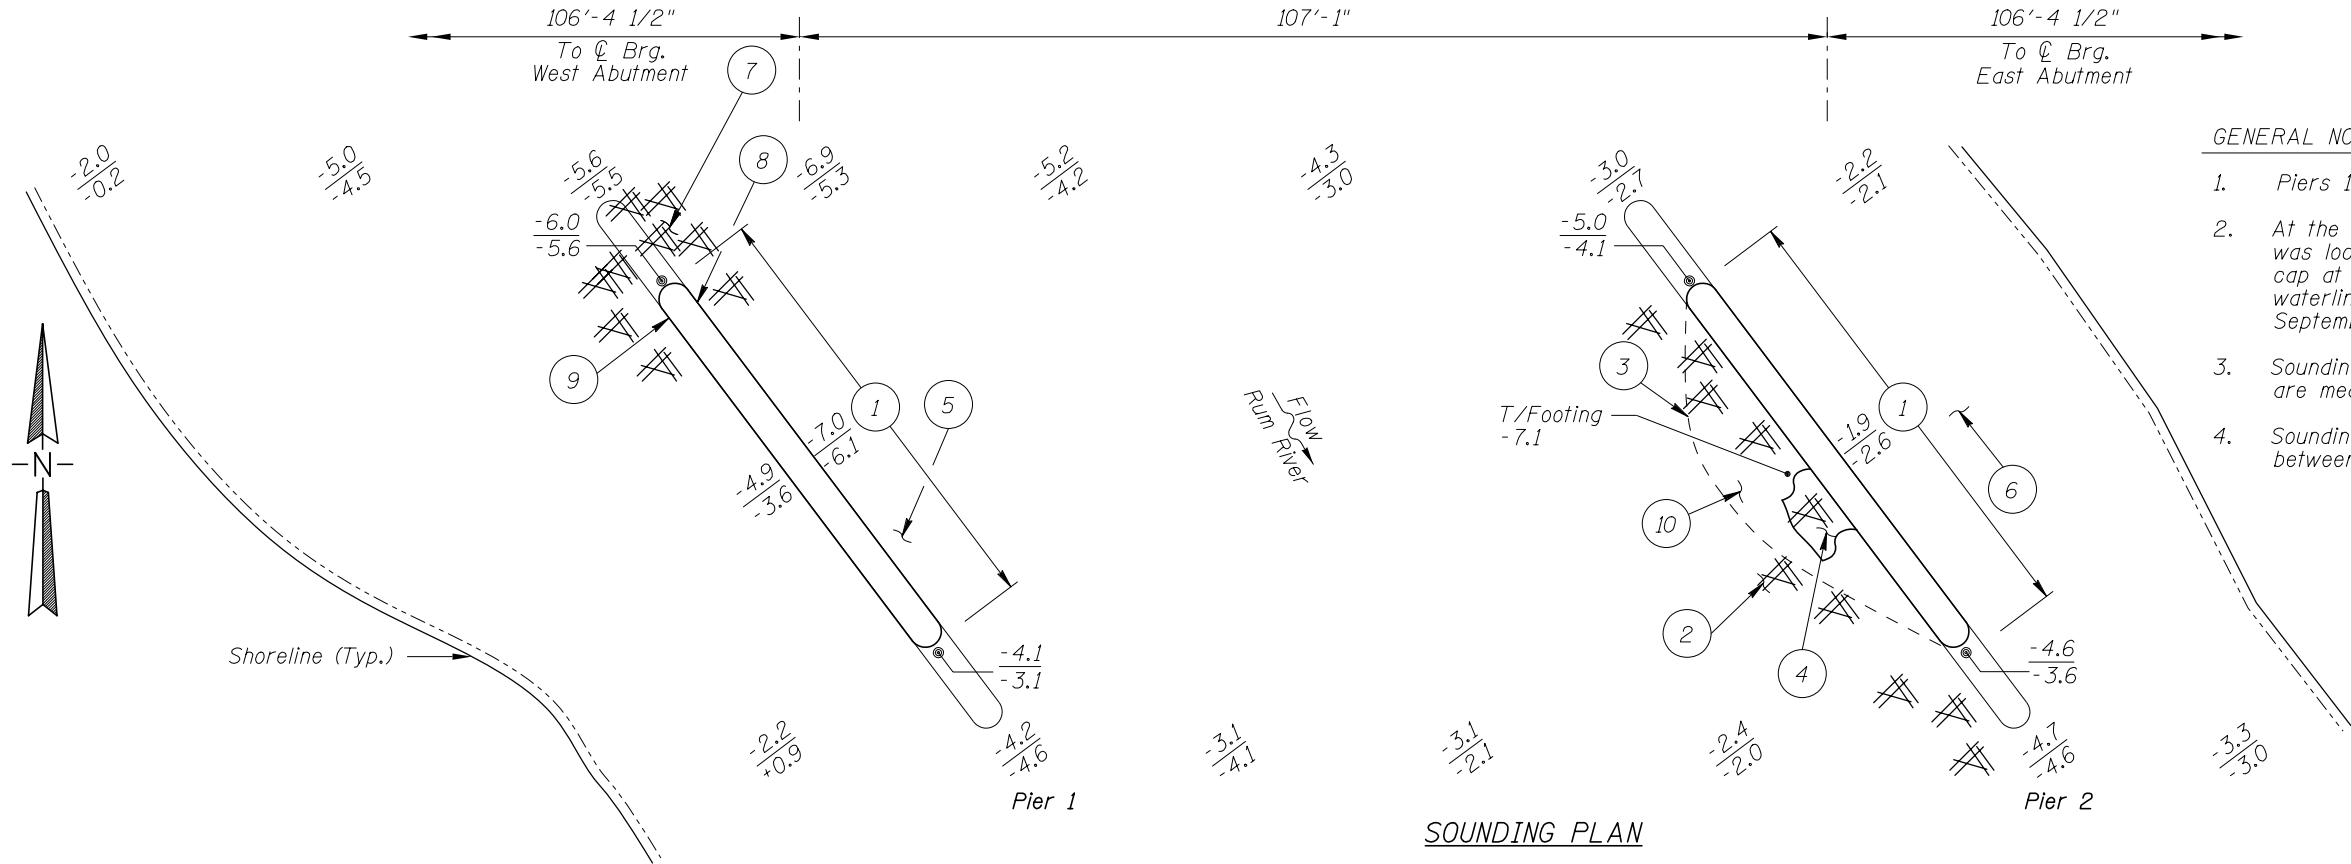
INSPECTION AND SOUNDING PLAN

- All concrete surfaces from 2 feet above the waterline to the channel bottom exhibited light scaling with random pockets of poor consolidation with typical penetrations of 1/8 to 1/4 inch in depth.

- A light accumulation of timber debris consisting of 4-inch-diameter and smaller logs and branches extended along the entire west face of Pier 2 and from the channel bottom up 2 feet.

- A 5-foot-radius, 3-foot-deep scour pocket was observed along the entire west side of Pier 2.
- The top of the footing was exposed along the west side of Pier 2 from the midpoint of the shaft to the downstream 1/4 point, and the exposed surface exhibited light scaling with typical penetrations of 1/8 to 1/4 inch in depth.

- A light to moderate accumulation of 8-inch-diameter and smaller timber debris was observed at the upstream nose of Pier 1 and extended from the channel bottom up 1 foot.

- Two 1-foot-high areas of moderate scaling were located on the east face of Pier 1 at the waterline. One area was 2 feet long with up to 1 inch of penetration and was located 6 feet south of the upstream nose. The other area was 1 foot long with up to 1/2 inch of penetration and was located 14 feet south of the upstream nose.
